DPRCG 2024 CONVOCATION

Going Down the Tubes

The Project

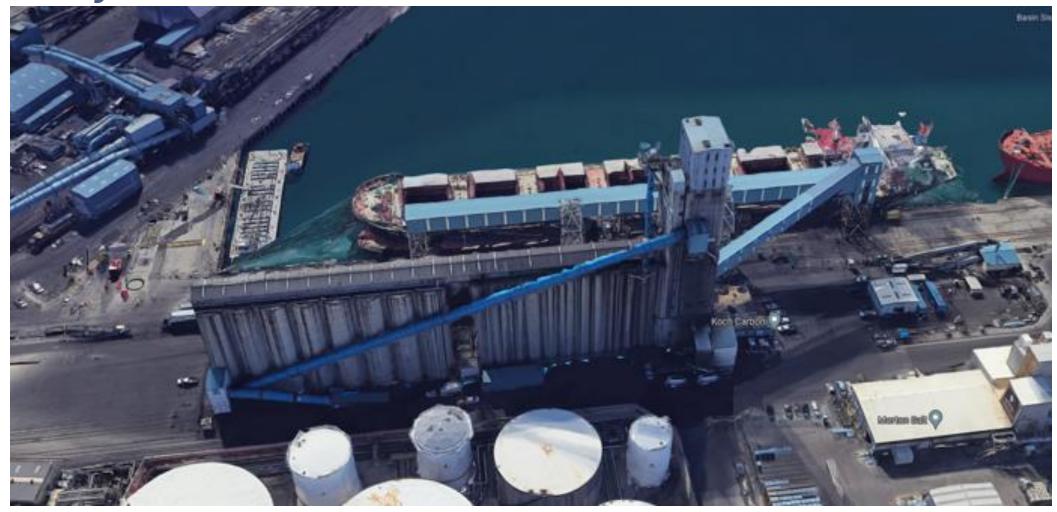
- Bulk-handling minerals terminal at a port transferring minerals to and from ship and shore
- Upgrade of two "tube galleries"
 - 10' wide tubes with conveyors inside
 - BC-1 was 100' long and rose from ground level up to 40'
 - BC-2 was 475' long and suspended from 25' up to 175'

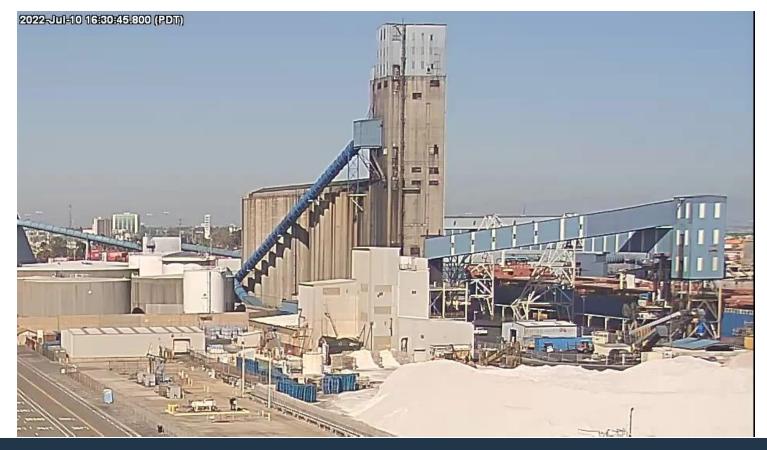
■ BC-2 collapsed onto BC-1

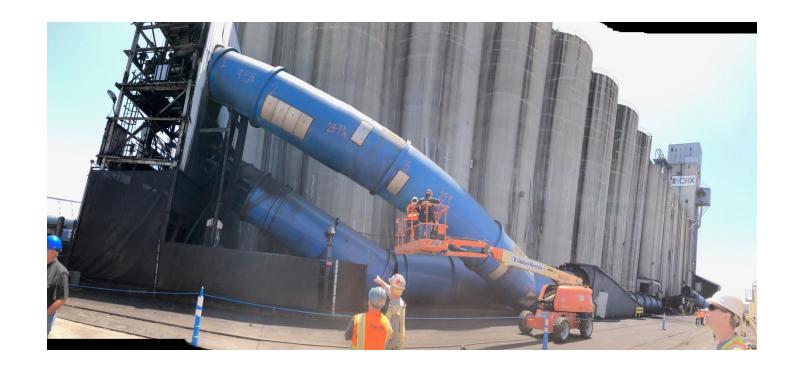
- Both tubes damaged
- No minerals could be transferred via these tubes
- One tube hit the cargo portion of a dump truck (not the cab, but the driver was injured)

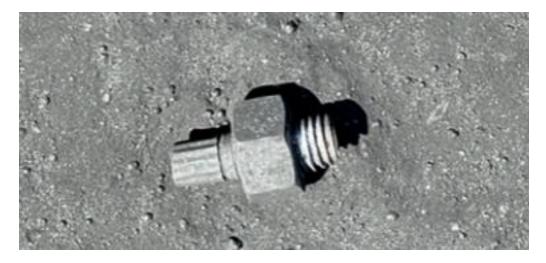
The bolt reacts to the fastening torque and shears at the Torque Control (TC) groove when the tension is
